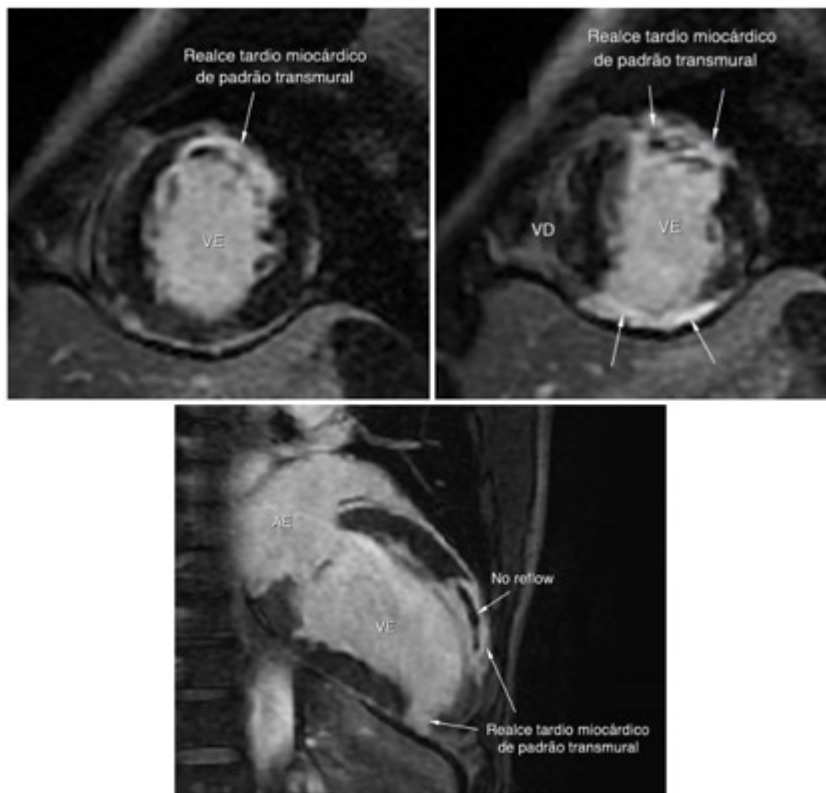
Figura 2 – RMC mostrando o realce tardio transmural e o no reflow.
